Manhole Inspection Summary

Manhole # S23OO1030MH

Insp Date: **7/11/07 12:20 PM**

Location Address: **4701 FALLS RD**

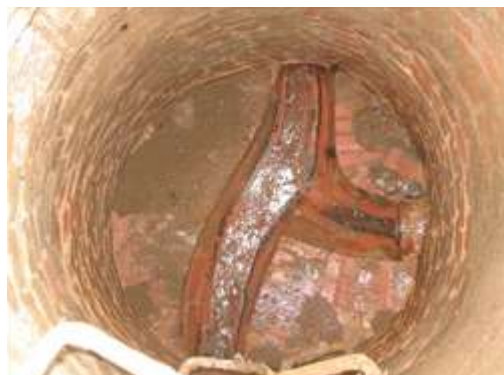
Top View

Corroded steps. Evidence of surcharge - Bench debris.

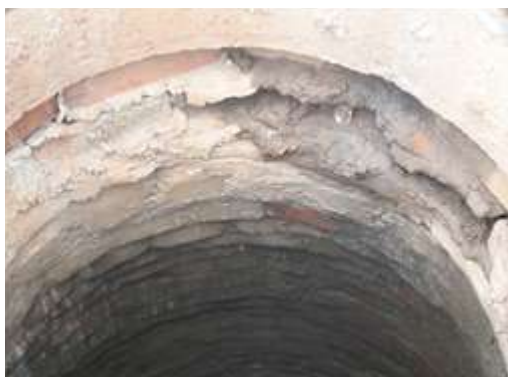
Defect

Frame leaks. Adjustment deterioration, loose brick and infiltration. Corbel and Barrel infiltration - other side.

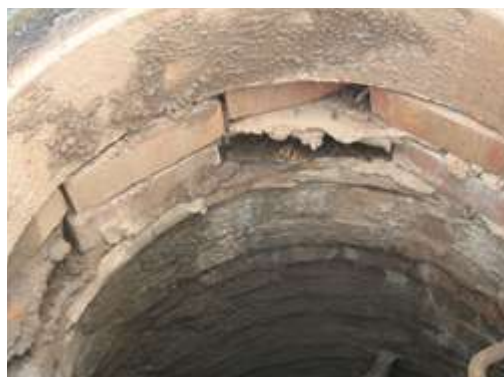
Defect

Frame leaks. Adjustment deterioration, loose brick and infiltration. Corbel and Barrel infiltration.

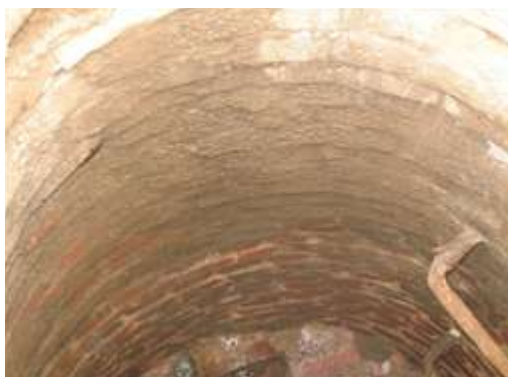
Defect

Adjustment, Corbel and Barrel infiltration.

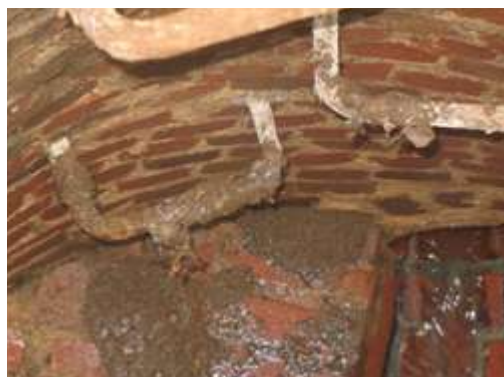
Defect

Evidence of surcharge - Bench debris. Corroded steps.

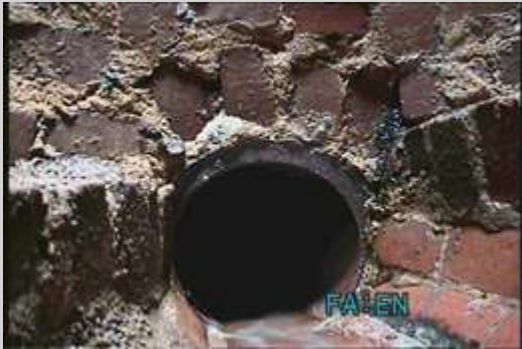
8 in. Circular Gravity Sewer Pipe Out @ 12 O'Clock

Barrel deterioration and infiltration. Channel deterioration.

Infiltration: **None** Pipe Seal Cond: **Cracked**

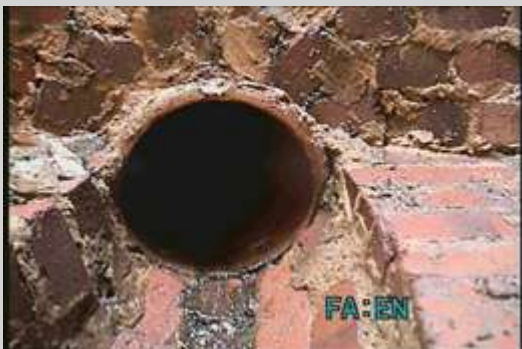
8 in. Circular Gravity Sewer Pipe In @ 3 O'Clock

Infiltration: **Evidence** Pipe Seal Cond: **Cracked**

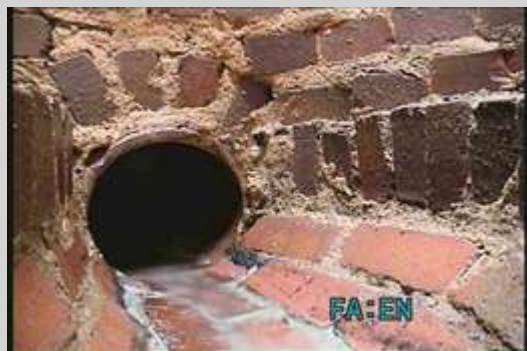
Pipe In @ 6 O'Clock

Infiltration: **Evidence**

Pipe Seal Cond: **Broken**
